14 pages
OPERATION CASTLE

Project 3.5 [UT]

BLAST EFFECTS ON MISCELLANEOUS STRUCTURES

11 July 1955

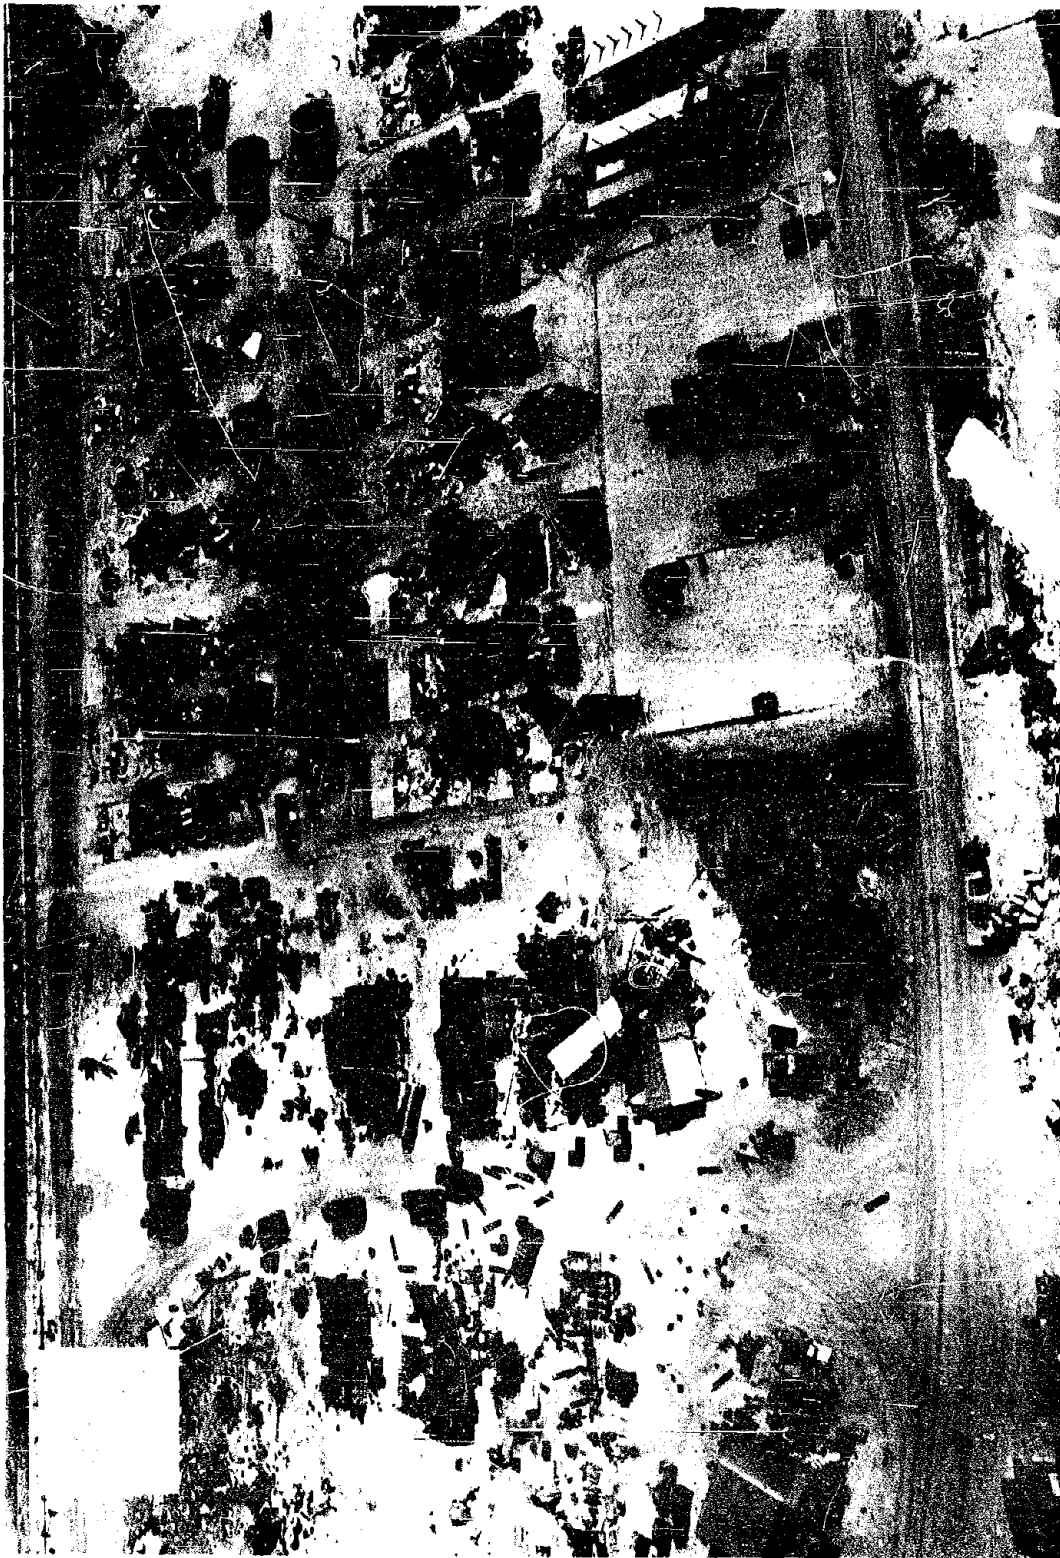
Fig. 3.1 Postshot Aerial View of Camp and Warehouse Area on "e" Island, 14-3/4 Miles from GZ

The type of damage inflicted to the tents on Tare Island can be described in four general categories. The first type of damage which is of interest occurred in the living area where the sides of the eight-man tents were oriented about 62 degrees from the direction of burst as shown in Fig. 2.1. Generally, the first two rows of tents in each block were moved bodily from their slabs. This type of damage is best illustrated by referring to Figs. 3.1 - 3.5.

The second type of damage also occurred to eight-man tents, this type of damage consisted of failure of the two 2" x 6" hip rafters on the end or side of the tent most nearly facing ground zero; the end result being a partial or complete collapse of the tent roof. This type of damage can be observed in Figs. 3.1, 3.2, 3.5, and 3.6.

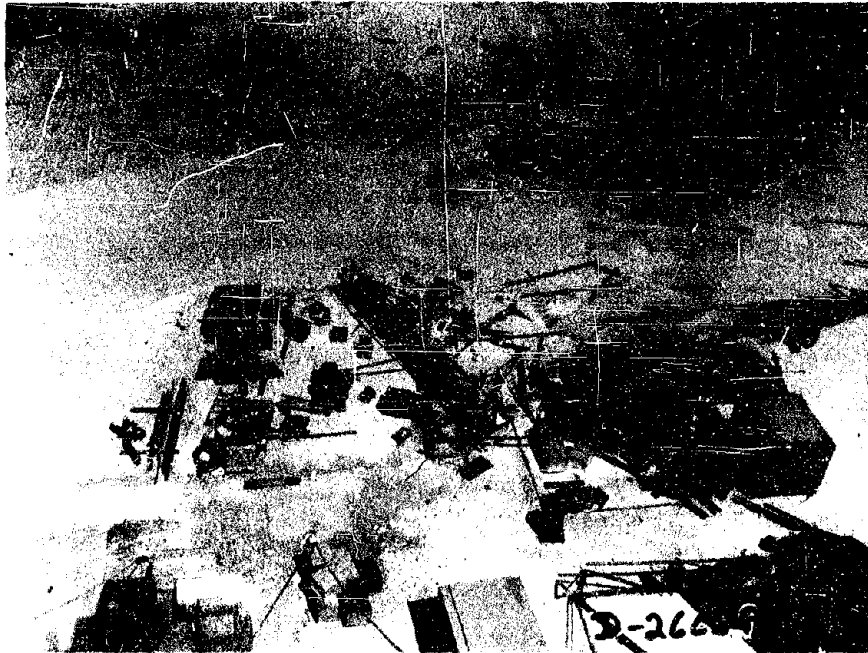
Fig. 3.3 Postshot Tent Damage in Scientific Area, Tare Island
14-3/4 Miles from GZ

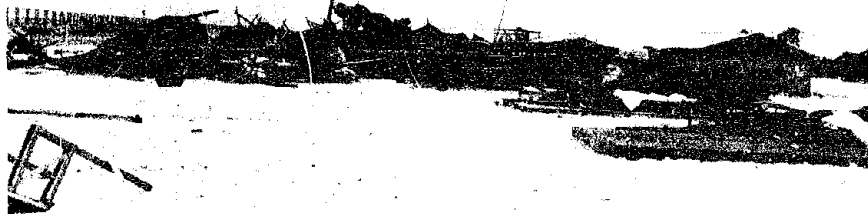
Fig. 3.4 Postshot Tent and Latrine Damage, Tare Island, 14-3/4 Miles
from GZ

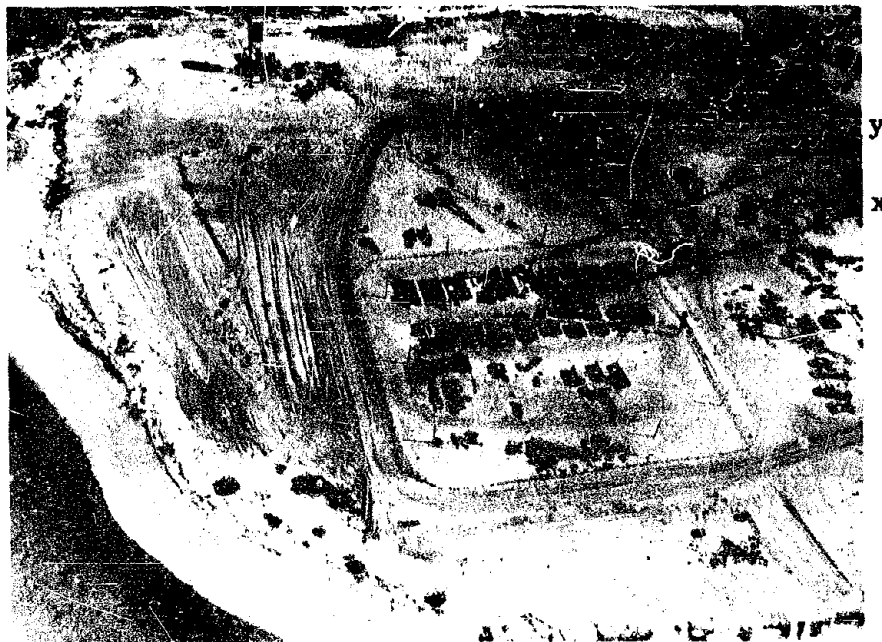
Fig. 3.6 Technical and Scientific Areas, Tare Island, Postshot, 14-3/4 Miles from GZ

The fourth type of tent damage was fire in the technical area. It will be noted that a fire was started in the tent marked X (Origin I) in Fig. 3.6 and spread downwind (Figs. 3.8 - 3.10) finally engulfing a Signal Corps trailer. A similar fire (Fig. 3.11) started in the tent marked Y (Origin II) in Fig. 3.6 but did not spread. The initial fires

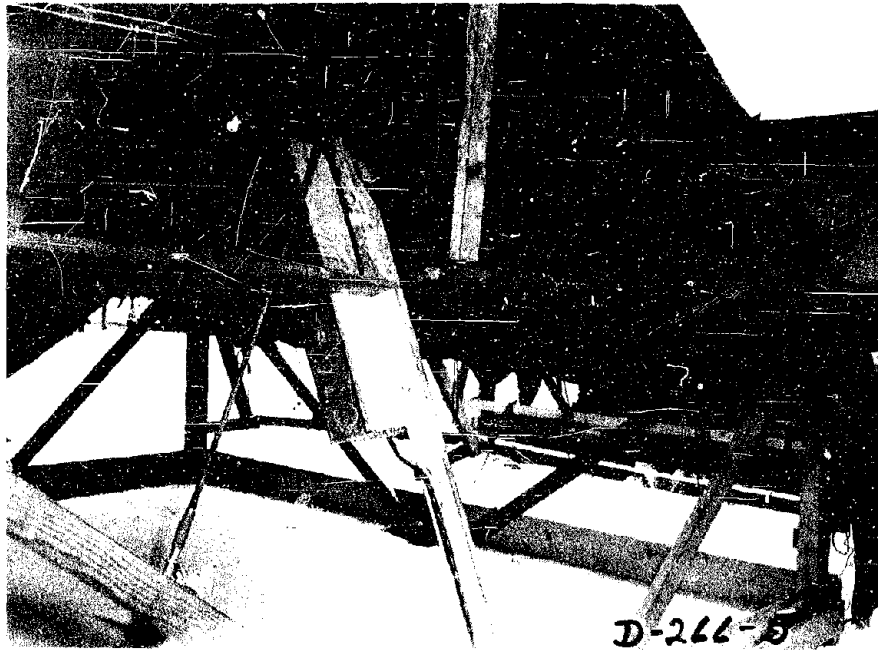
The third type of damage was the failure of the 2" x 4" top plate (see Fig. 3.7) in the ends of the four-man tents which faced nearly into the blast. Most of the four-man tents and some of the eight-man tents suffered this type of damage in varying degrees of severity. Few tent roofs collapsed because of this type failure.

Fig. 3.7. Typical Damage to Four-man Tents, Tare Island, Postshot, 14-3/4 Miles from GZ

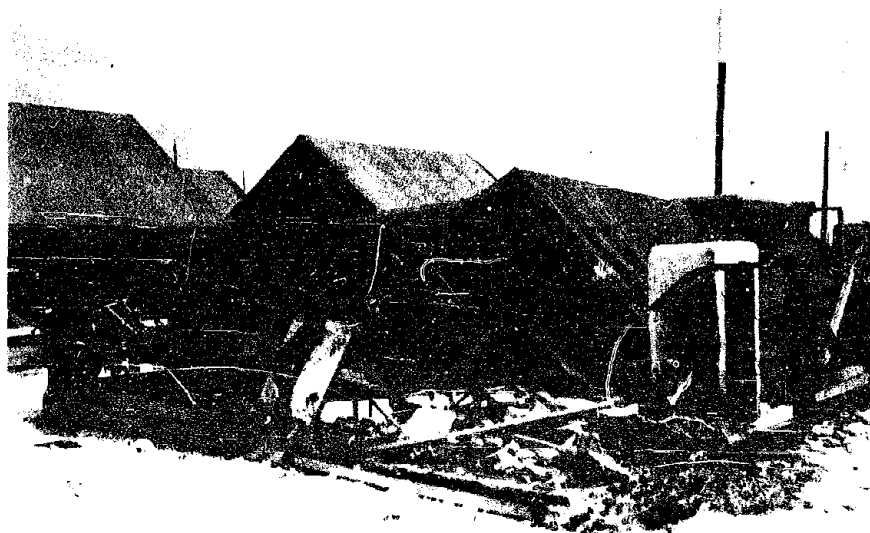
were caused by electrical shorts at the master switch control panels, the power having been left on during the shot. There was no evidence of damage due to primary thermal radiation. The reasons for the fire spreading from its origin can be fairly well established. First, the fire spread downwind. The surface winds were brisk and fairly constant in direction. Second, all the tents except one downwind of fire origin had gasoline stored in them. Also, some tents had paint, polyethylene, and other inflammables stored inside. Two of the tents contained portable gasoline-driven generators. The tent immediately downwind of the fire origin had six 5-gallon and two 1-gallon gasoline containers. The next tent downwind had a number of polyethylene bottles in storage.

Fig. 3.8 Fire from Shot 1 (Origin I) which Spread to Tents Downwind, 14-3/4 Miles from GZ

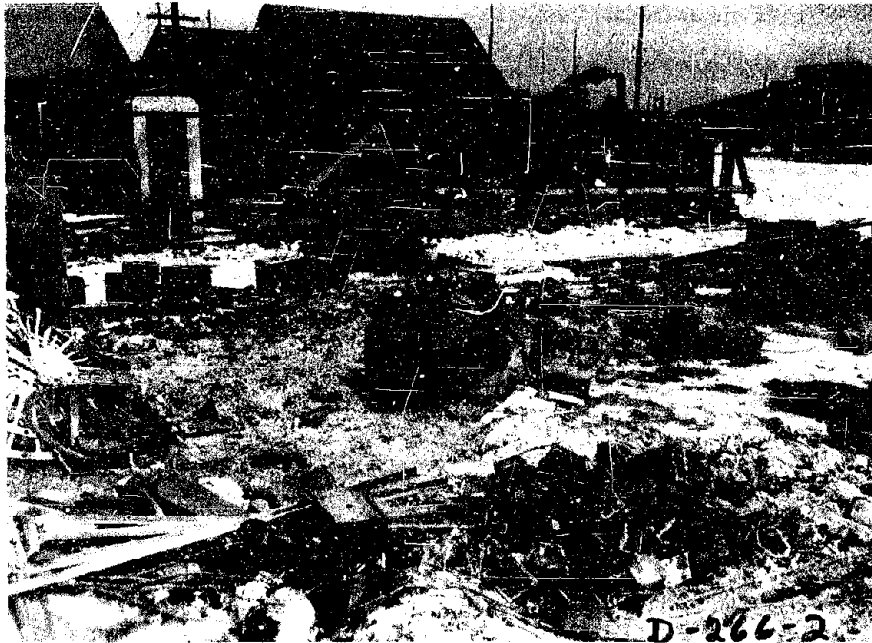
Fig. 3.9 Fire Damage to Tents (Origin I), 14-3/4 Miles from GZ

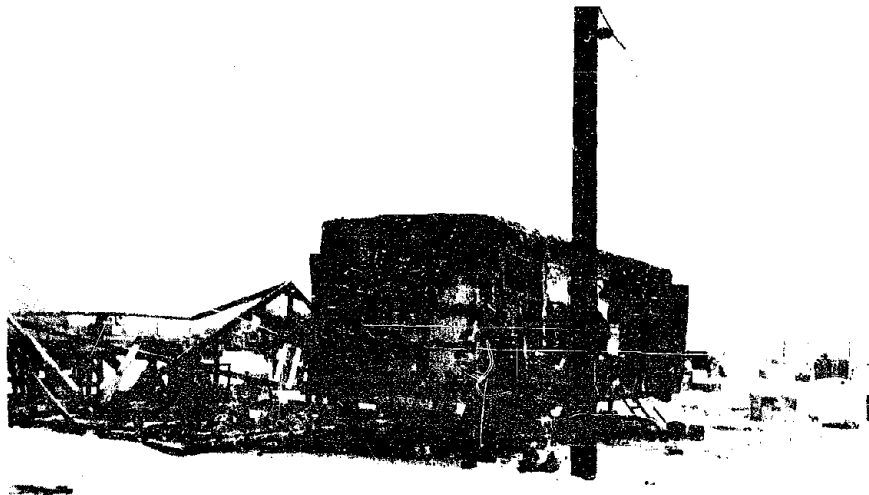
Fig. 3.10 Fire (Origin I) Damage to Signal Corps Trailer, 14-3/4 Miles from GZ

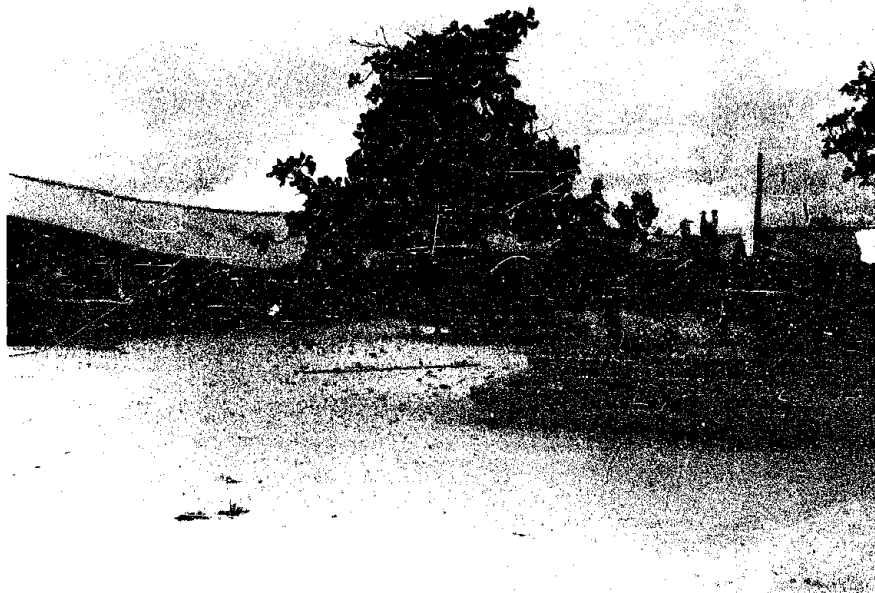
Fig. 3.13 North Dining Wing of Mess Hall, Tare Island, Postshot 14-3/4 Miles from GZ

Figures 3.12 and 3.13 are pre- and postshot views of the north dining wing of the mess hall which most nearly faced ground zero. Most of the side was caved in and the rafters were badly damaged. Figures 3.14 and 3.15 are pre- and postshot views of the south dining wing. The entire side and large sections of the roof were blown out. One 16' x 40' section of roof was hurled a distance of 75 feet from its original location. Other views of interest are Figs. 3.2 and 3.16 - 3.19.

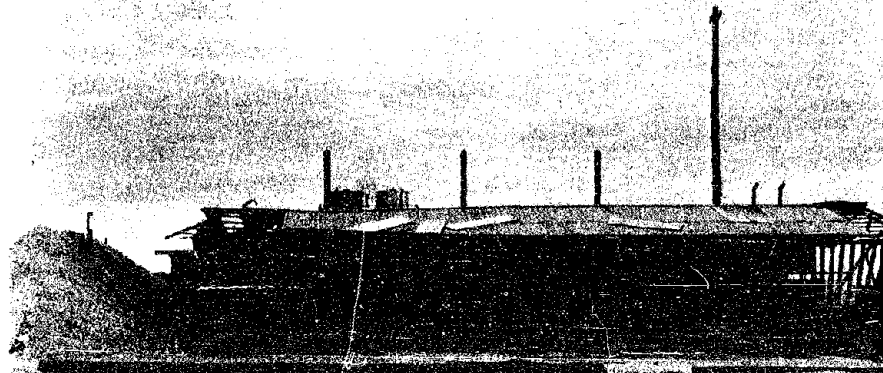
Fig. 3.21 Scientific Power House, Tare Island, Postshot,
14-3/4 Miles from GZ

Figures 3.20 and 3.21 are pre- and postshot views of the scientific generator station looking east. Some of the rafters were broken, some sheet metal was ripped off the roof, and most of the plywood siding on the end of the building away from ground zero was blown off. Figure 3.22 is the end of this same building facing away from ground zero.

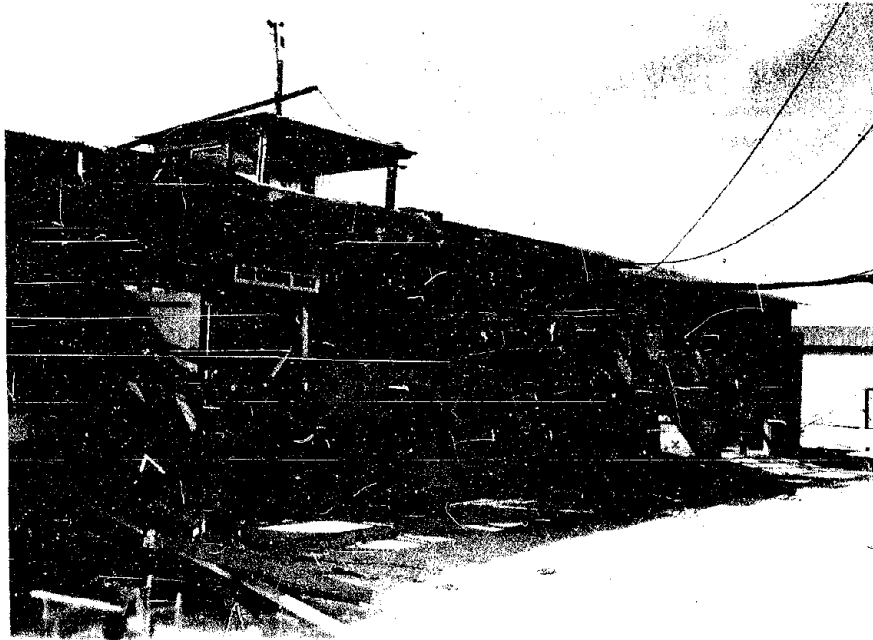
Fig. 3.30 Air Operations and Control Tower, Peter Island,
Postshot, 15-1/2 Miles from GZ

Figure 3.30 is a view of the front side of the Air Operations building of the airport facility on Peter Island. It is noted that the side has been caved in, the studs being broken near their center except at the corners of the building and door frames. The 2" x 8" rafters were broken near the center of their span. Also, about one-half of the sheet metal roofing had been blown off as shown in Fig. 3.31. Most of the sash had been removed from the control tower before the burst. The glass which was left in place was not damaged.

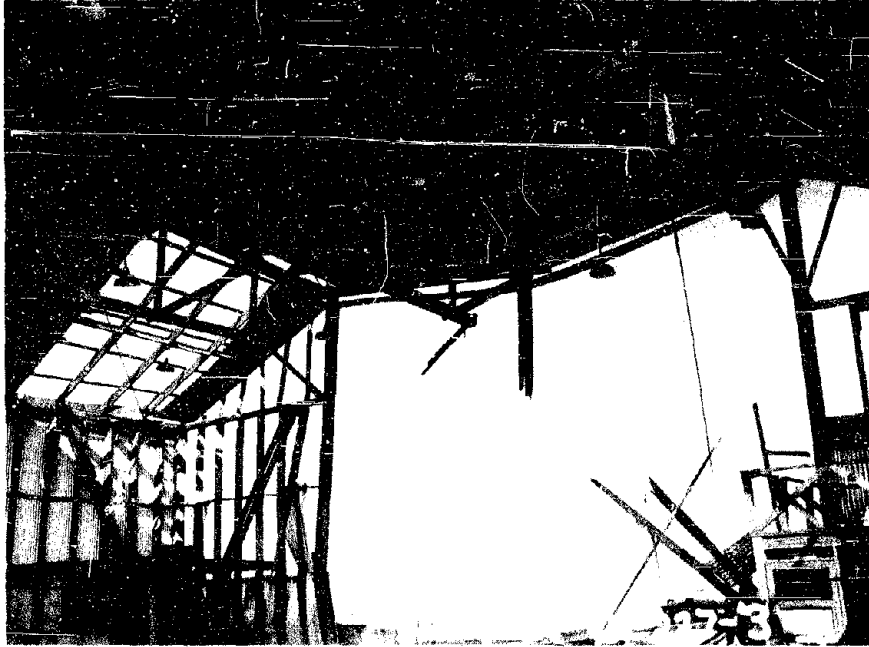
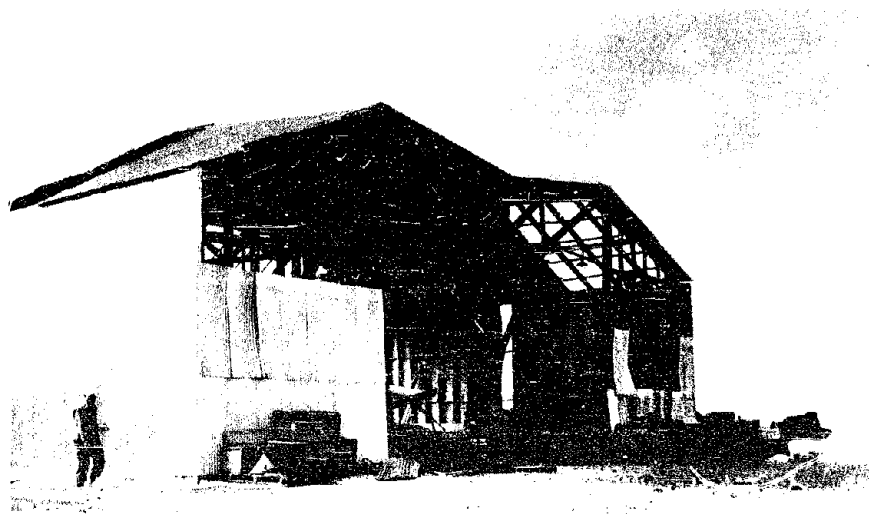
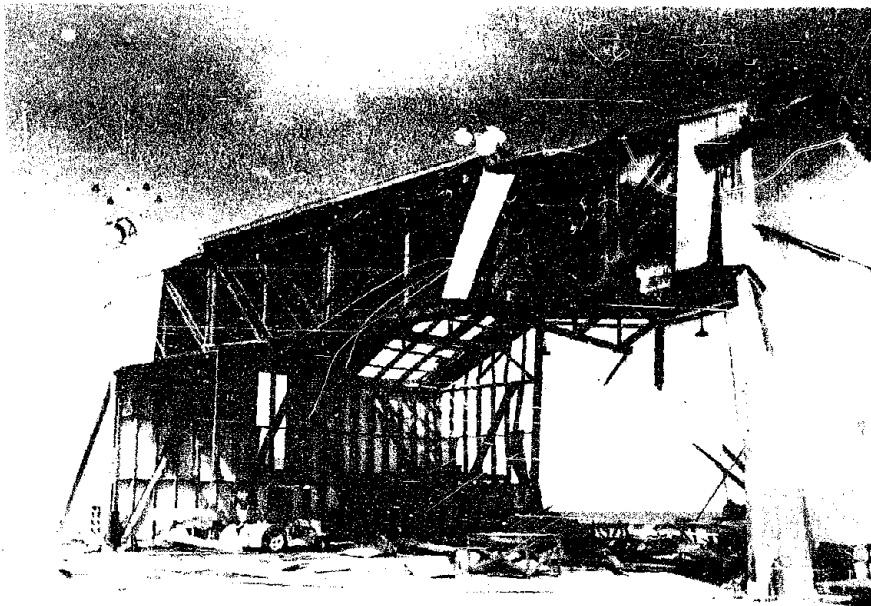
This structure suffered moderate to severe damage. The northwest (back) end of the hangar, including the 75-foot truss, had been almost completely blown out. This is best illustrated in Figs. 3.32 - 3.35. The lower chord of the 75-foot truss on the southeast (front) end was deflected outward several inches at the center of the span. Also, a considerable number of the 2" x 10" rafters were broken by the blast.

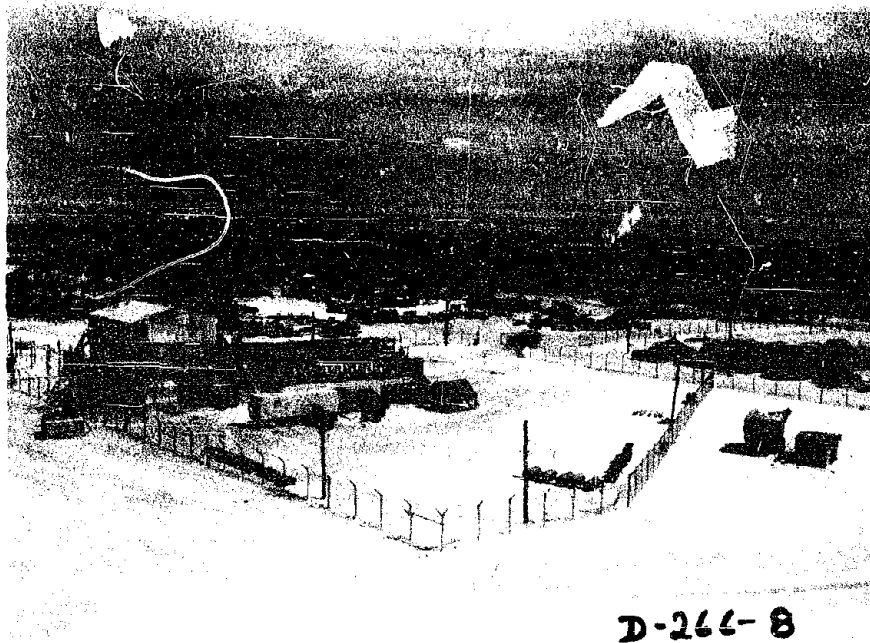
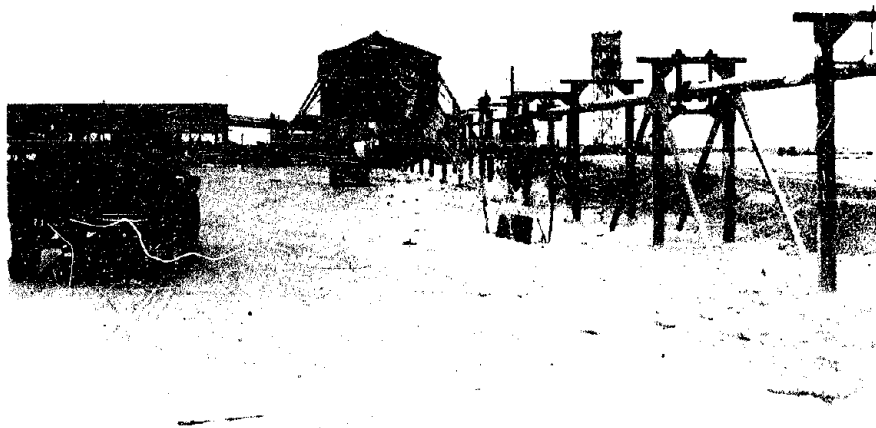
The steel photographic tower received no damage from the blast. The aluminum sheet metal siding on the steel frame building (Station 50) was dished inward on the west end and blown off on the east end. Figures 3.36 - 3.38 illustrate this damage. The sheet metal had been removed from the north side prior to shot time for Shot 1.

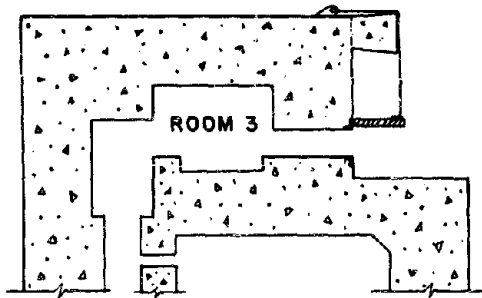
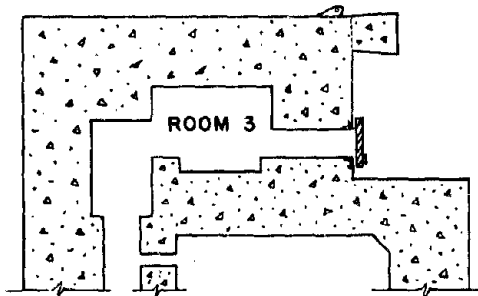
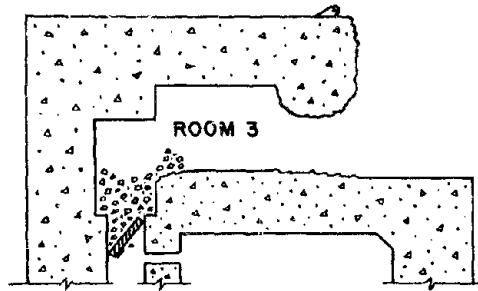
Fig. 3.42 Position of Shutter Door, Station 1341, Able Island,
7500 ft from GZ

Due to the failure of the wall supporting the shutter door, the blast wave entered the building. The shutter door was hurled inward and dropped part way down the chimney, lodging in a position No. 3 as shown in Fig. 3.42. The forces from the blast also broke the latches and hinges from three other doors, namely, the lead door entering the equipment room on the first floor, the light weight steel door between rooms No. 1 and No. 4 on the first floor, and the main personnel door on the second floor. This door is shown in Fig. 3.45. The following doors did not fail: two exterior lead doors on the side of room No. 4, and three steel doors on the outside of the back wall of the equipment room.

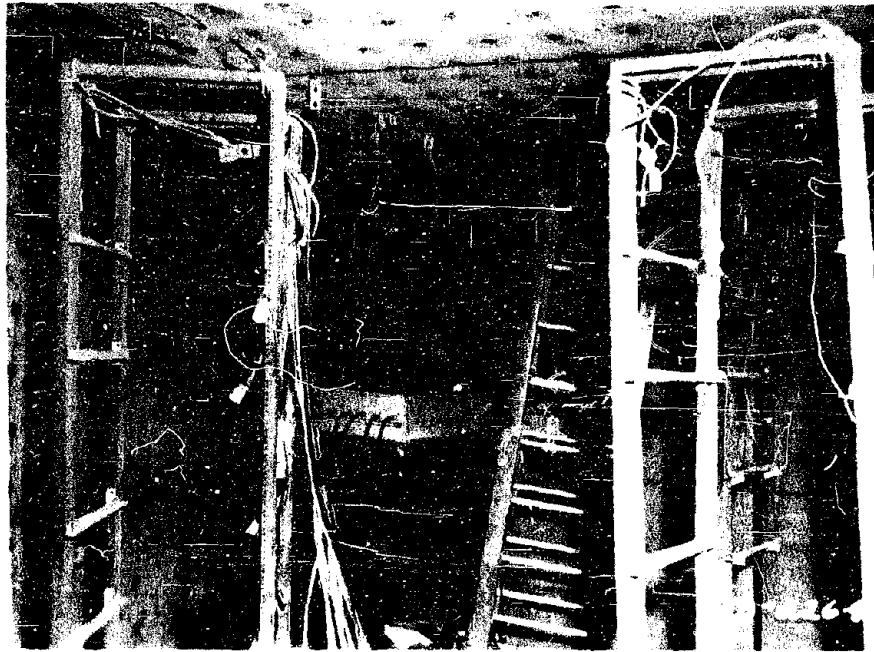
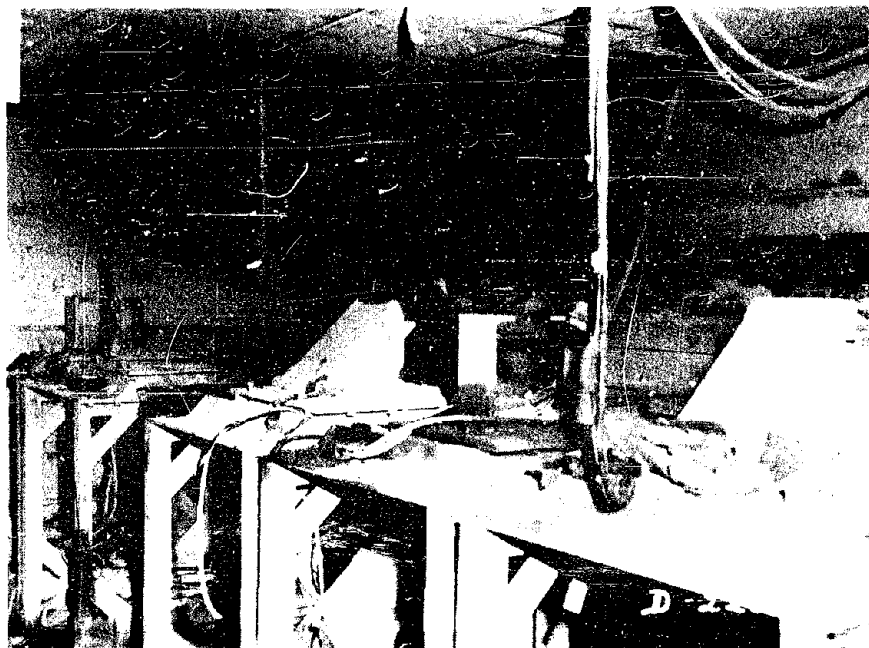
(3) The scientific equipment, equipment racks, and other interior structures were severely damaged. This damage can be noted in Figs. 3.48 and 3.51.

Fig. 3.48 Interior I - Room No. 3, Station 1341, Able Island, Postshot, 7500 ft from GZ

Fig. 3.51 Interior - Room No. 2, Station 1341, Able Island, Postshot, 7500 ft from GZ

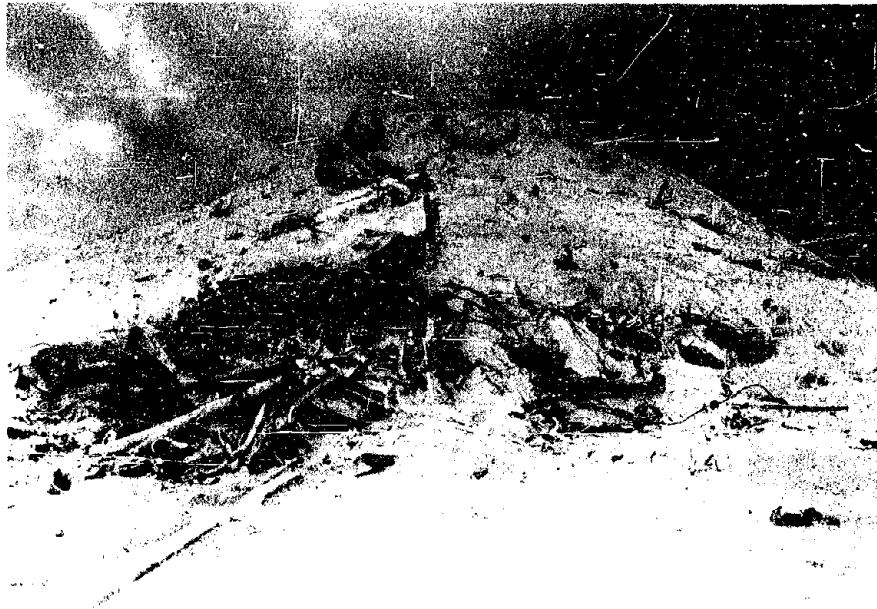
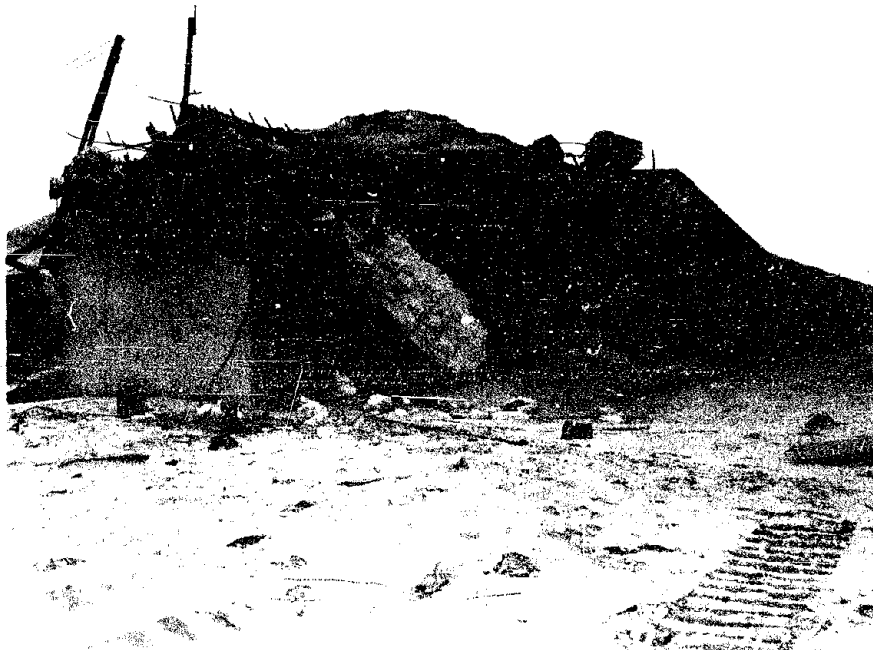
The failures which occurred to the reinforced concrete walls were at the structural discontinuities and the retaining walls. Figures 3.52 and 3.53 are exterior views of the front and rear of Station 1200. Portions of the parapet and retaining walls at the rear of the structure were torn off by the blast. Figure 3.54 shows extensive cracking of the retaining wall at position No. 1 in Fig. 2.7. Figure 3.55 is a view of a corridor wall near the doorway at positions No. 2 and No. 3 respectively as shown in Fig. 2.7. These cracks and a crack in the corridor wall and ceiling at position No. 4 in Fig. 2.7 were the only major structural failures inside the building.
